MEMORANDUM

Site Assessment: Carter Carburetor, St. Louis, Missouri

TDD: T07-9503-001
PAN: EM01034SCA
OSC: Don Hamera

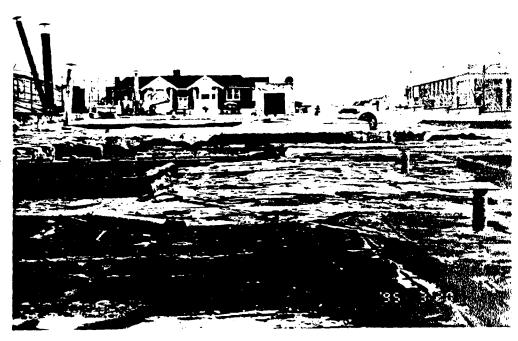
Frame No. : 3 Direction : E

- A hole in the site perimeter fence existed on the north end of the lot along Dodier Street, allowing unrestricted entrance onto the site.
- 2) A window frame missing from the west end of the north side of the diecast building allowed access to the building. It was evident that people had recently been in the building as evidenced from new beverage cans, trash etc. in the building.
- 3) In general, site conditions continue to deteriorate from the elements. The roof has collapsed in some areas, and direct access is available to the building's interior.

Comments : Roof collapsing

in over diecast room area of

LRA property

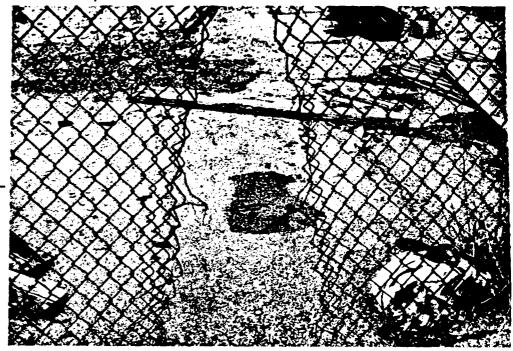
Frame No.: 1 Direction: S

Comments : Hole in fence in north fence along Dodier St.-

north lot LRA property

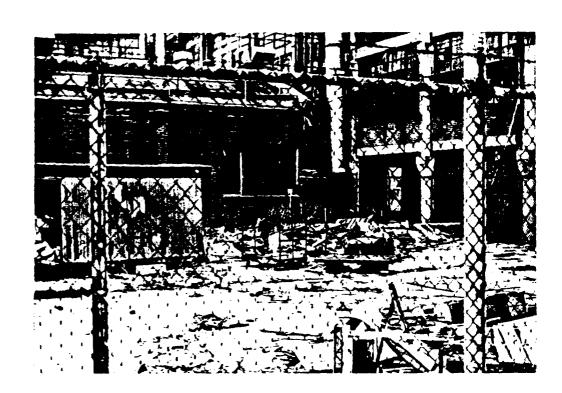
Frame No. : 2 Direction : SW

Comments: Window frame removed from north diecast

room-LRA property
